**PHASE ONE
ENVIRONMENTAL SITE ASSESSMENT
84 CANNIFTON ROAD NORTH, BELLEVILLE, ONTARIO**

Project Number: 220456-00
13 February 2023

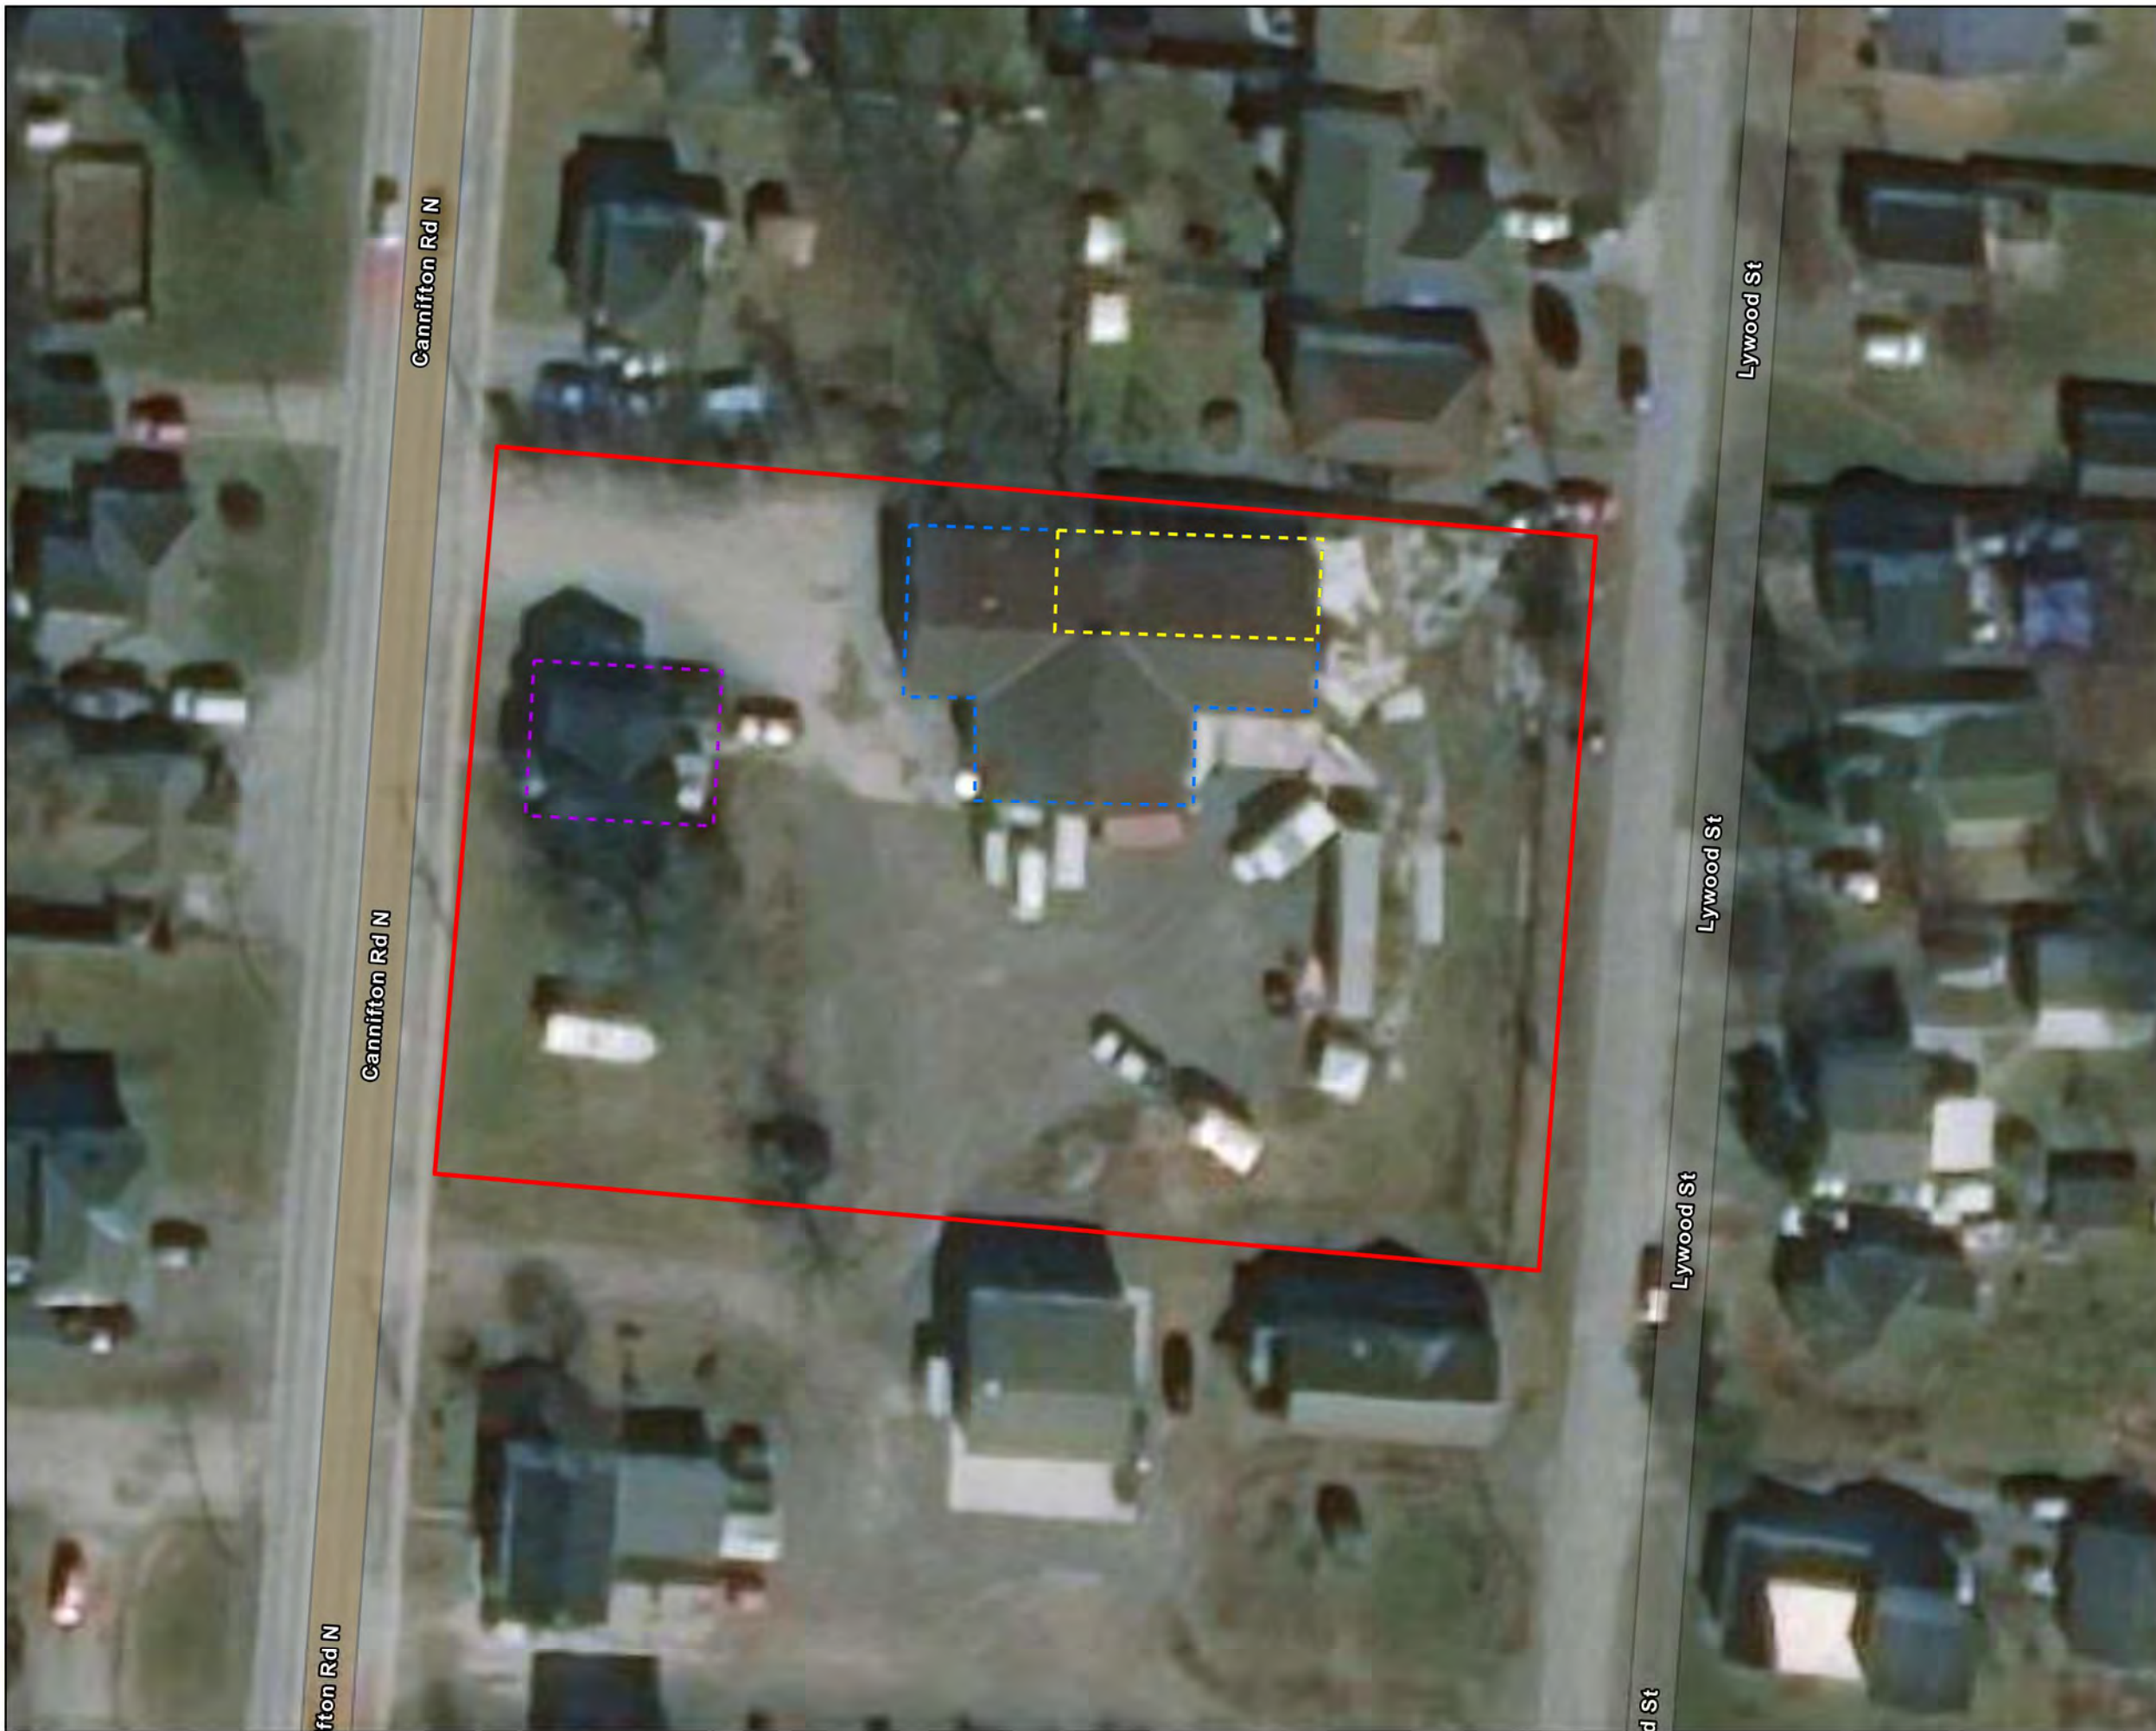
PROJECT # 220456		DATE February 10, 2023	
DRAWN PB	CHECKED AG	FIG NO. 02	REV 0

- Phase One Property Boundary
- Workshop Building (Existing Footprint)
- Dwelling (circa early 1900s)
- Workshop Building (1960s)

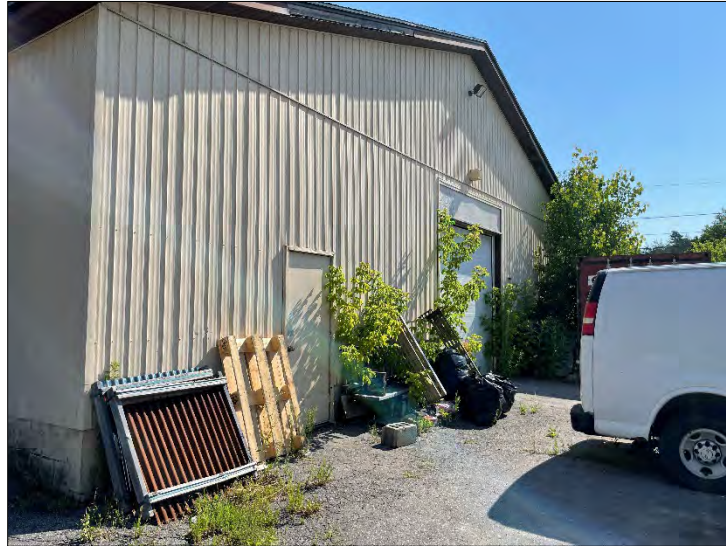
Front View of subject property at 84 Cannifton Road N main building.
Picture taken facing east from west side of the Site.

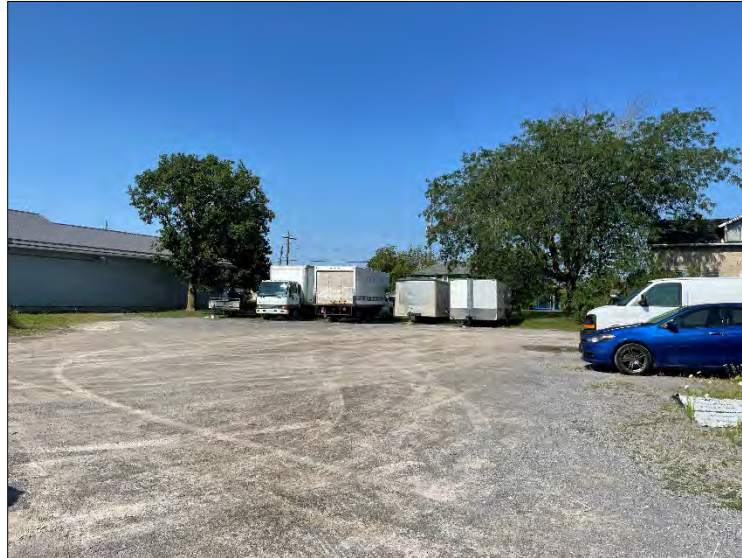
Parking area south of the main building at 84 Cannifton Road N.
Picture is taken facing southeast.

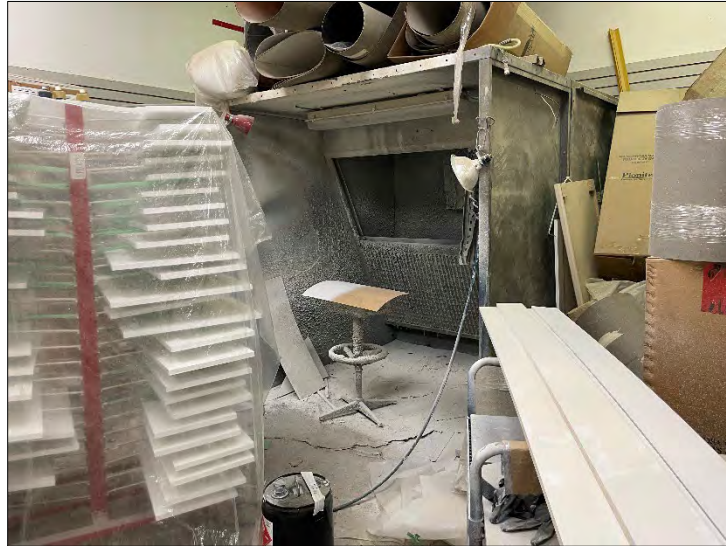
View of paint booth area located in work area at 84 Cannifton Road N.

Mr. Cawker confirmed that no vehicle or equipment repairs or maintenance is conducted on-site. Likewise, no liquid or solid subject wastes were reported to be generated on the Phase One Property. However, there is a paint spray booth in the woodwork shop which is vented through the southeast side of the building. Mr. Cawker indicated that to his knowledge there have been no spills on the Phase One Property. Mr. Cawker also indicated that the property was formerly occupied by a pool sales and maintenance business that stored concentrated chlorine liquid in aboveground storage tanks along the southeast wall of the building. These tanks were removed prior to 2016.

PCA#	PCA Description	Notes
28	Gasoline and Associated Products Storage in Fixed Tanks	Based on the age of the building, a concrete pedestal found in the basement, and a vent pipe observed along the northwest wall of the building, it is suspected that the dwelling on the Phase One Property was likely formerly heated using an oil-fired heating system.
Other	Paint Spray Booth	There is a paint spray booth used in the workshop building. Observations on-site included pails and cans of wood finishing lacquers, stains, and thinners stored in the paint spray area, and significant staining and debris on the floors.

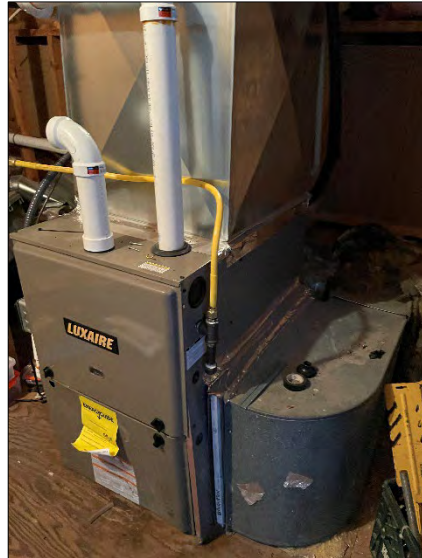
View of mechanical area located at 84 Cannifton Road N.

At the time of the site visit on July 22, 2022, the workshop building on the Phase One Property was heated via a natural gas fired forced air furnace and cooled via an exterior stand-alone air conditioning unit located along the east wall of the building. No evidence of any existing storage tanks was observed.

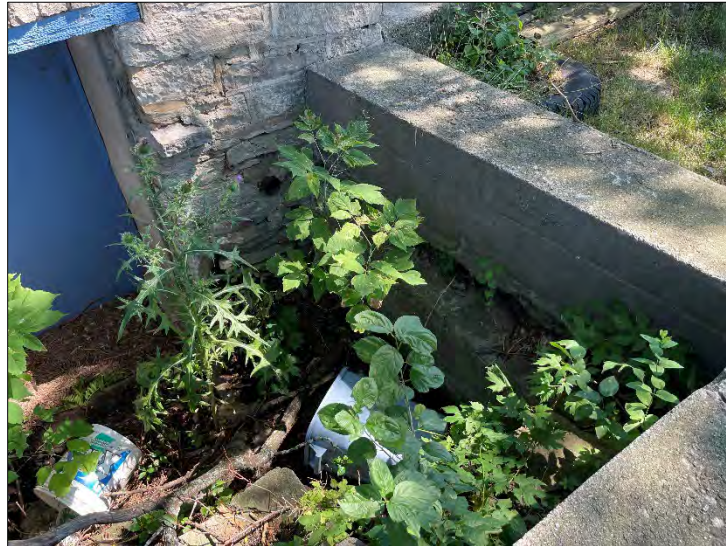
View of northeast corner of residential house, noting the historical vent pipe.
Photograph is taken looking west.

The dwelling was heated via a gas-fired hot water boiler system located in the basement of the building and cooled via window-mounted air conditioning units observed on the second storey. No storage tanks were noted on the Phase One Property. However, a concrete pedestal was noted in the basement along the northwest wall of the dwelling, indicative of a potential former aboveground storage tank. A vent pipe was also observed along the exterior of the northwest wall of the building, in the vicinity of the existing gas meter. No staining was observed on the floors in the vicinity of the pedestal. No information regarding the removal or volume of the former tank was available.
